Commencing Repair Works

The Spine Wall

Island House Lougharne
Spine Wall Condition and Approach to Repair

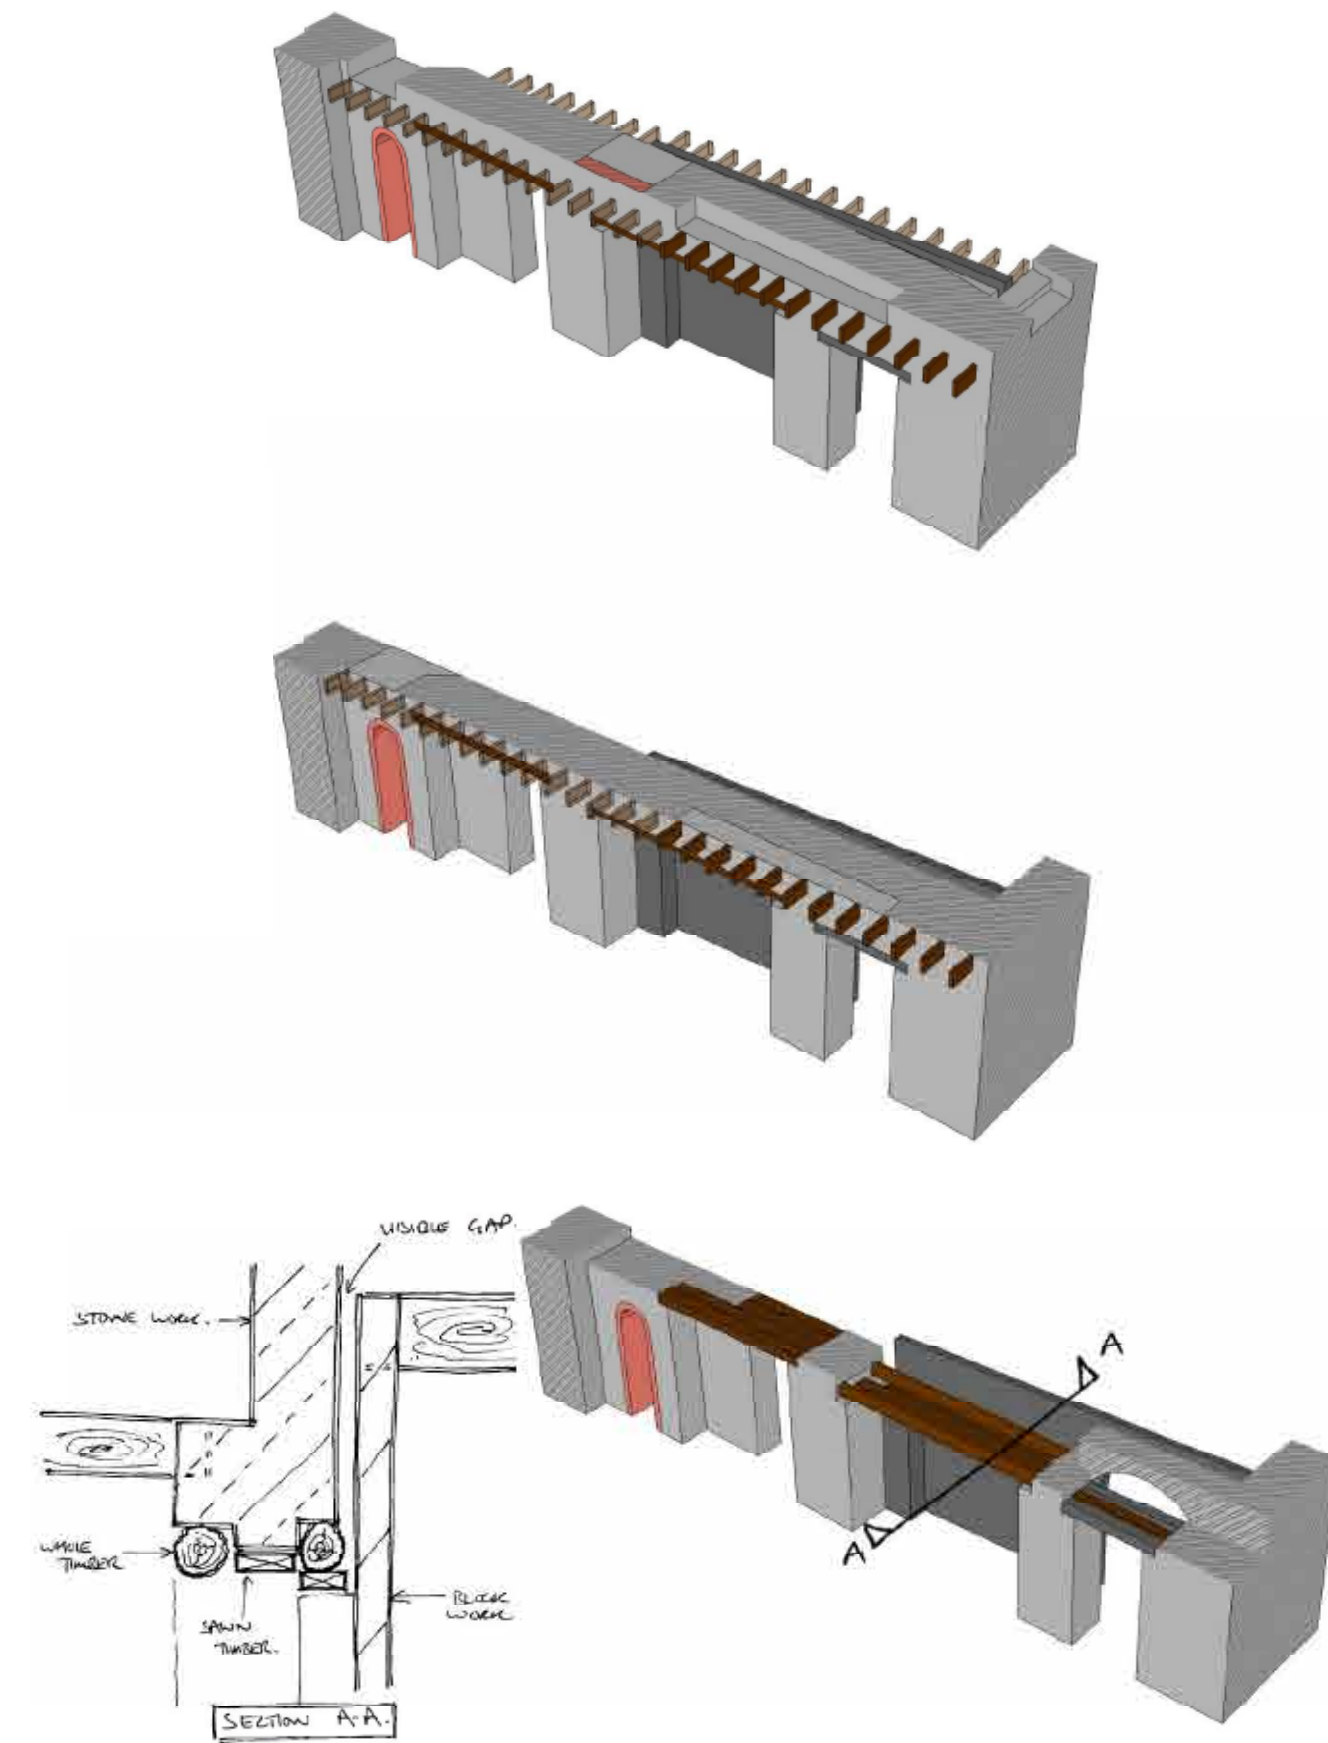
Above sections show the spine wall condition as of 09.06.2020

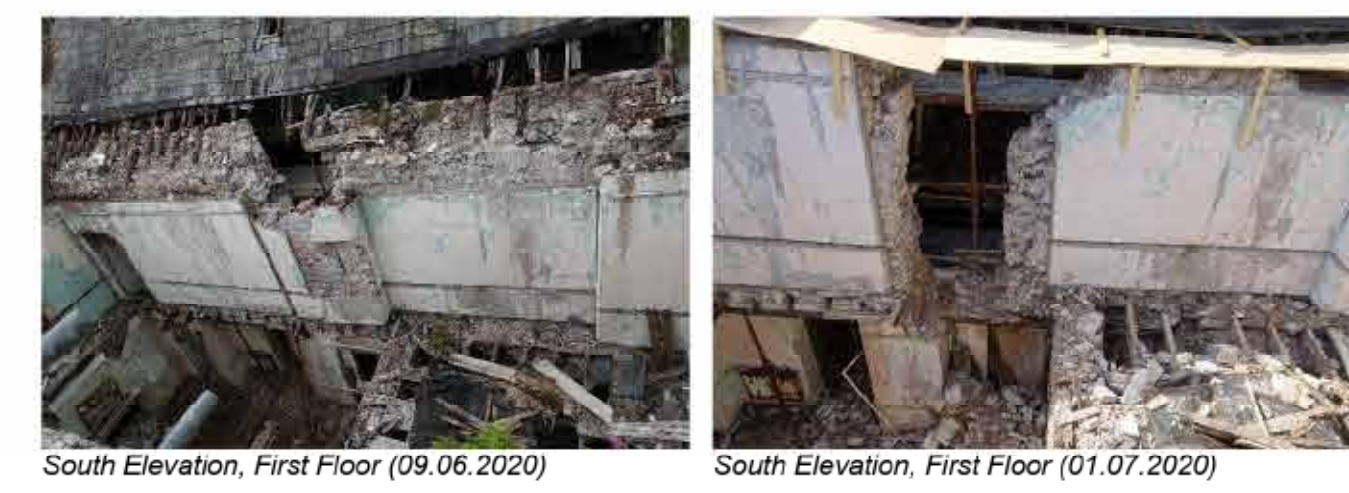
South Elevation, First Floor (09.06.2020)

- 3.8 The first-floor masonry panel between the western most opening and central bricked-up opening appears to be in sound condition. There is no clear evidence of movement in the form of cracking of finishes or otherwise.
- 3.9 This is likely due to the masonry being monolithic above the entire opening, meaning a secondary load path in the form of an arch could develop as the lintel degraded. Indicative load paths are marked up on the image below.

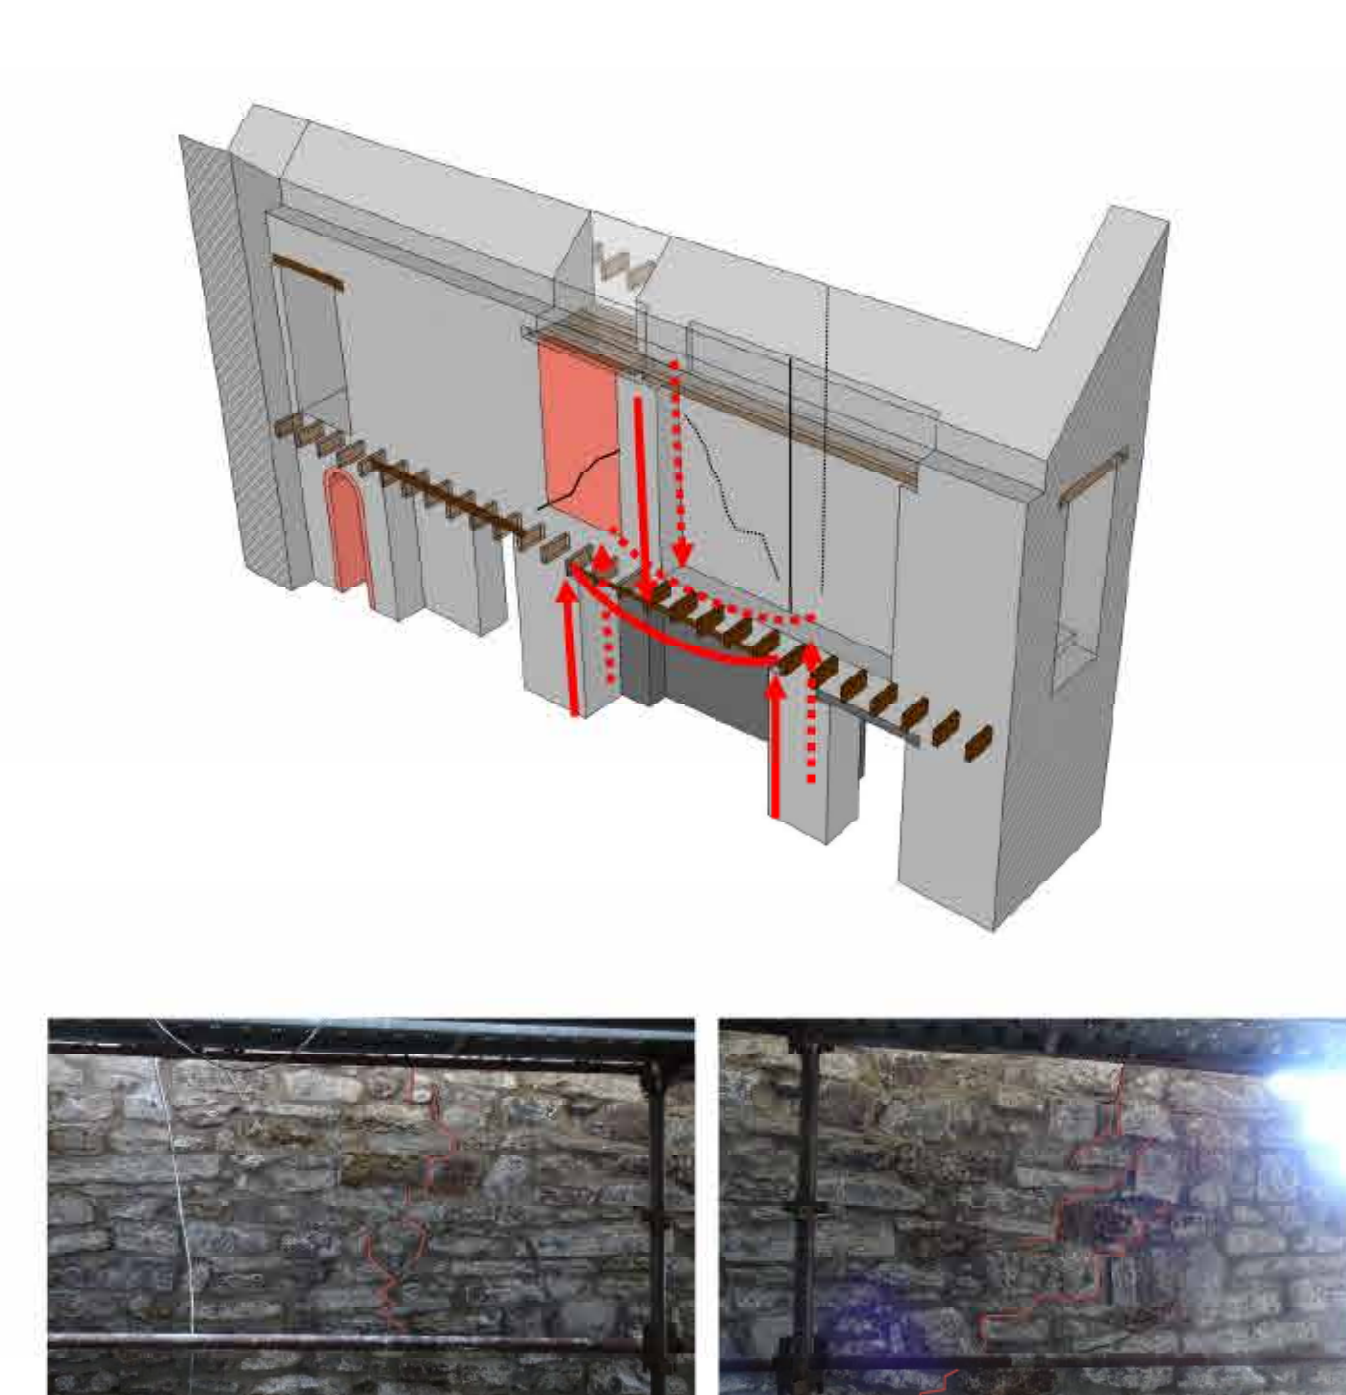
Cracks in North Elevation, First Floor

- 3.11 The central section of first-floor masonry (central bricked-up opening to the mid-point of the recess in the southern elevation) is in worse condition. Both the finishes and masonry itself exhibit cracks indicative of movement due to failure of the lintels beneath.
- 3.12 In this location the first-floor masonry is not monolithic over the ground floor opening below, it is broken by the central opening. In this arrangement the arching secondary load path does not have the opportunity to develop and all the load must be taken by the lintel. As such, as the lintel has degraded the masonry has moved enough to cause cracking.
- 3.13 Indicative load paths and crack locations are shown on the image below.

- 4.1 Following the clearance of the loose and severely damaged masonry the remainder of the spine wall is to be repaired in situ.
- 4.2 This involves the replacement of decayed timber lintels and the stitching of cracks due to movement in the masonry caused by the decayed lintels.
- 4.3 To allow the lintels to be replaced the wall will need to be supported with needle beams above the lintel level. Outline proposals for this are given in M/W sketch SK_04. (Note: since this sketch was prepared, the cross wall south of the spine wall has been removed. Hence the propping arrangement will be altered, but the principles are unchanged.)

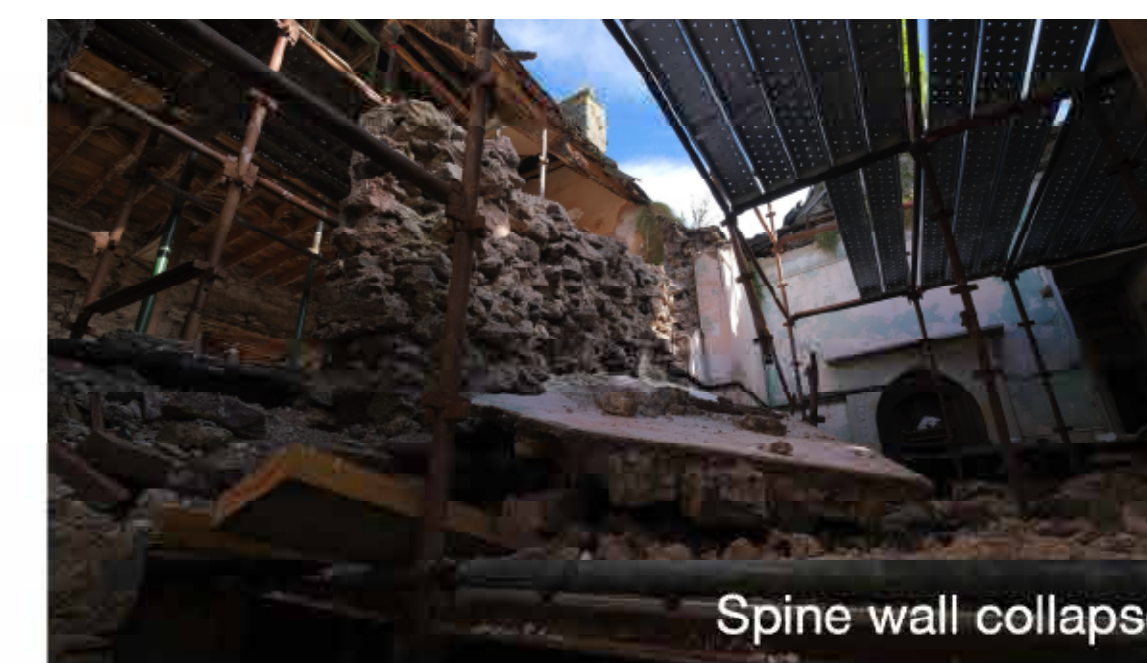
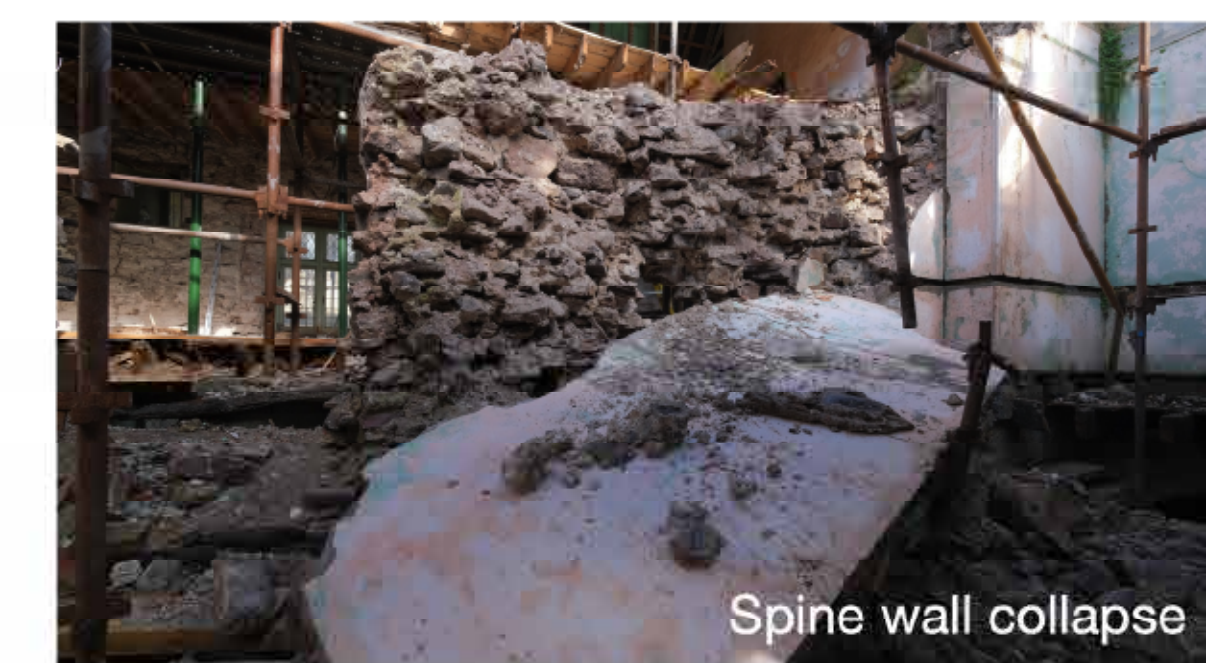
Spine wall collapse

As the wall was inspected, it collapsed. Thanks to careful planning and assessment of the risks, no one was hurt. After further assessment of the remaining wall, it was determined that water ingress from the failed valley gutter above had washed away the walls core. Leaving two skins of stone with only cement plaster and pointing holding it together. The wall was carefully dismantled down to stable areas ready for rebuilding. All suitable stone from the wall was cleaned for re-use. The Structural Engineers & Architects amended their drawings and re-issued a Listed Building Consent application.
