Archaeology

Trench 2

Trench 1

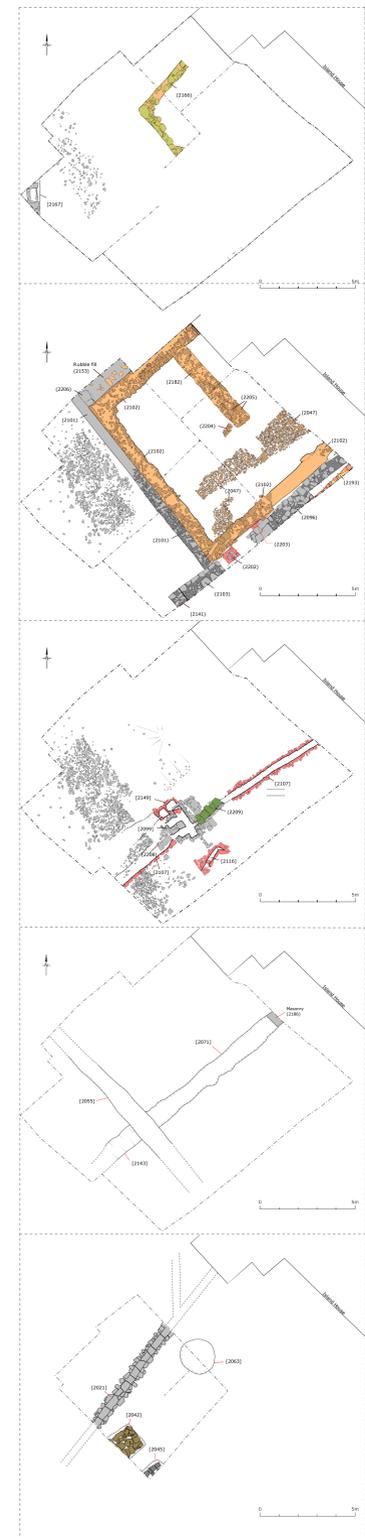
Trench 2 is located west of Island House. As with Trench 1 it was positioned within an area that was thought to contain a previously demolished wing of the house shown in an etching by antiquarian Maris Curtis circa 1856 (top right).

Only two features were recorded. A large stone drain (2167), which although silted up still has flowing water. The drain was cut through natural gravel layers, formed in slate and pinkish sandstone.

A section of wall (2166) was uncovered, it has been truncated by later activity. The wall is clay bonded and constructed of a local pinkish sandstone. The wall may have been part of a retaining wall with clay used as a water resistant barrier.

Expansion of a sequence of stone walled buildings in use between 300-400 years. Again, evidence of clay packed behind walls to create a water-resistant barrier. Suggested sequence of construction. (A) (2202) and (2203). (B) (2193) (C) (2096), (2103) and (2141) (D) (2102), (2182) stone floor (2204) and cobbled surface (2047) (E) (2206) (F) (2101)

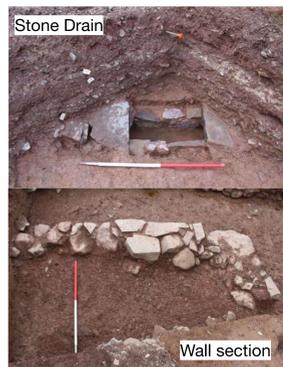
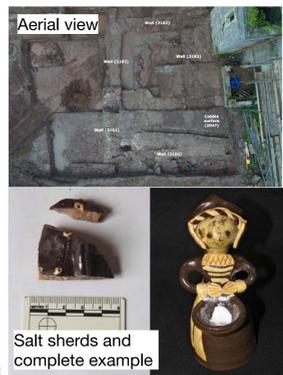
Stone drain (2021) which ran across the trench to serve the privy of Island House. It was constructed of pinkish sandstone. Two 19th century rectangular garden features were found, (2042 & 2045). Both later covered over with rubble material. The rubble contained 18th Century wine bottle glass, iron nails and a wide range of medieval pottery including industrially produced tableware of 19th/20th century. A circular pit (2063) was located, filled with animal bones, 18th century wine bottle glass and post medieval pottery. A copper halfpenny coin from the reign of George I dated 1718,
