# Environmental Reconstruction at Island House, Laugharne

Final Report January 2023 (draft)

Report commissioned by Island House Restoration Ltd.

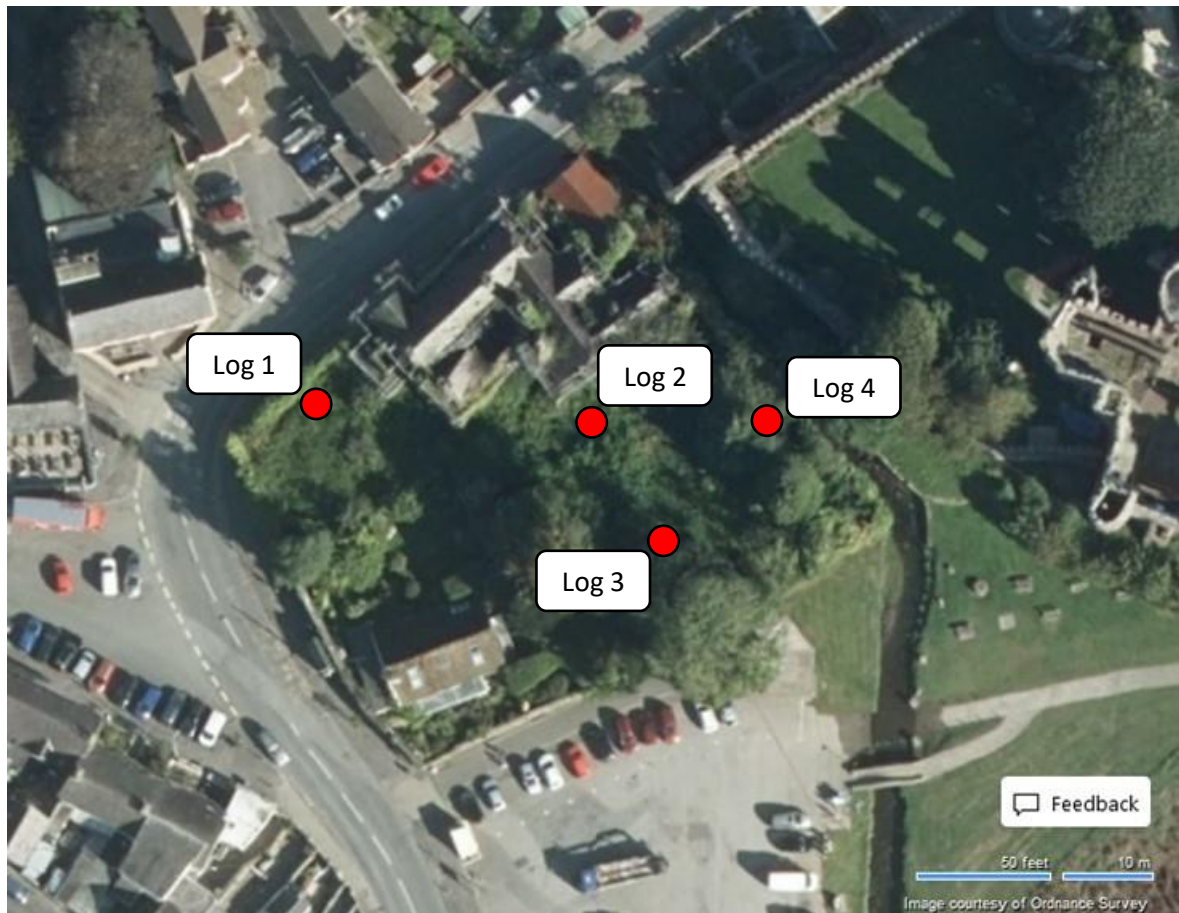
Figure 1: Location of sediment logs within the Island House boundary (Image from Bing Maps)

Four exposed sediment sections within the footprint of the Island House site were logged in August 2021 and November 2021 (Figure 1). Log 1 comprised a sediment section exposed by Dyfed Archaeological Trust's excavation work; it was initially described in their 2020 report (DAT, 2020). Log 2 was located on the western margin of a small watercourse that formerly ran beneath Island House. Logs 3 and 4 were taken from excavated pits.

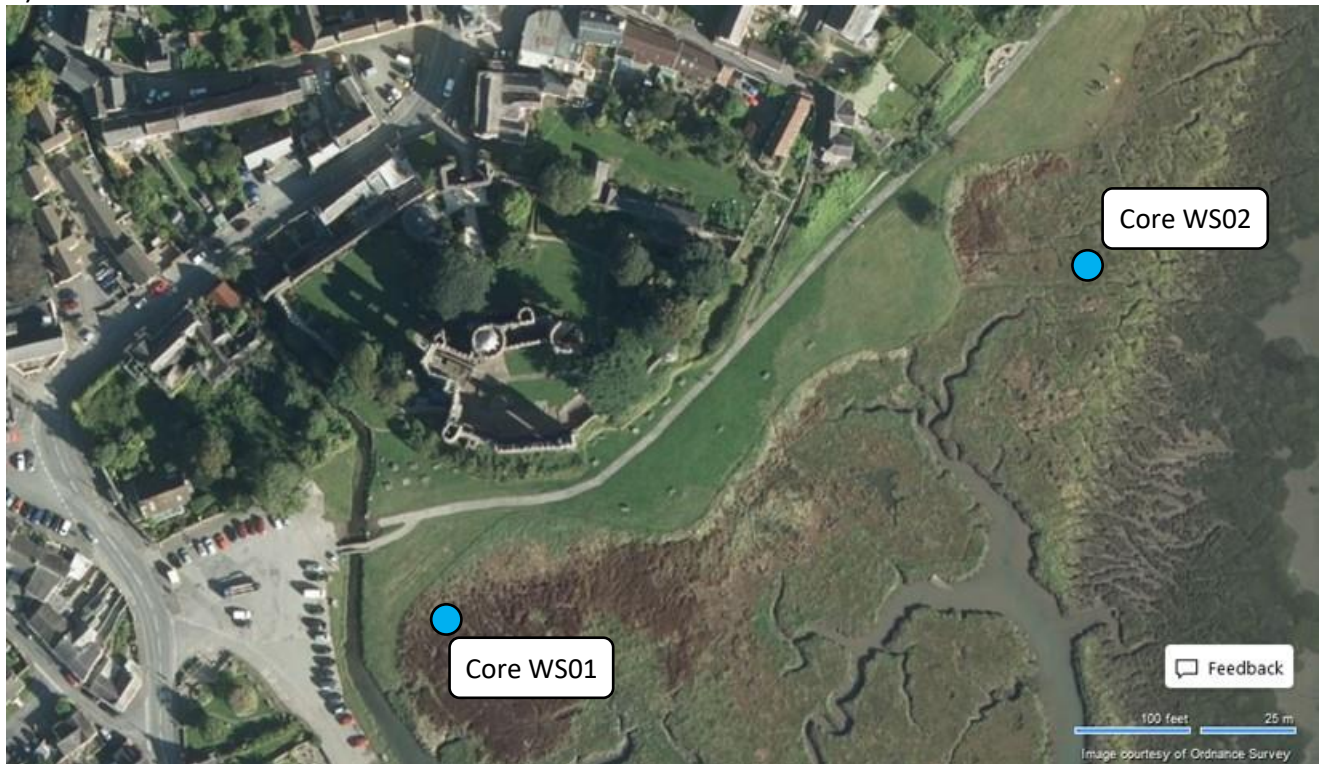
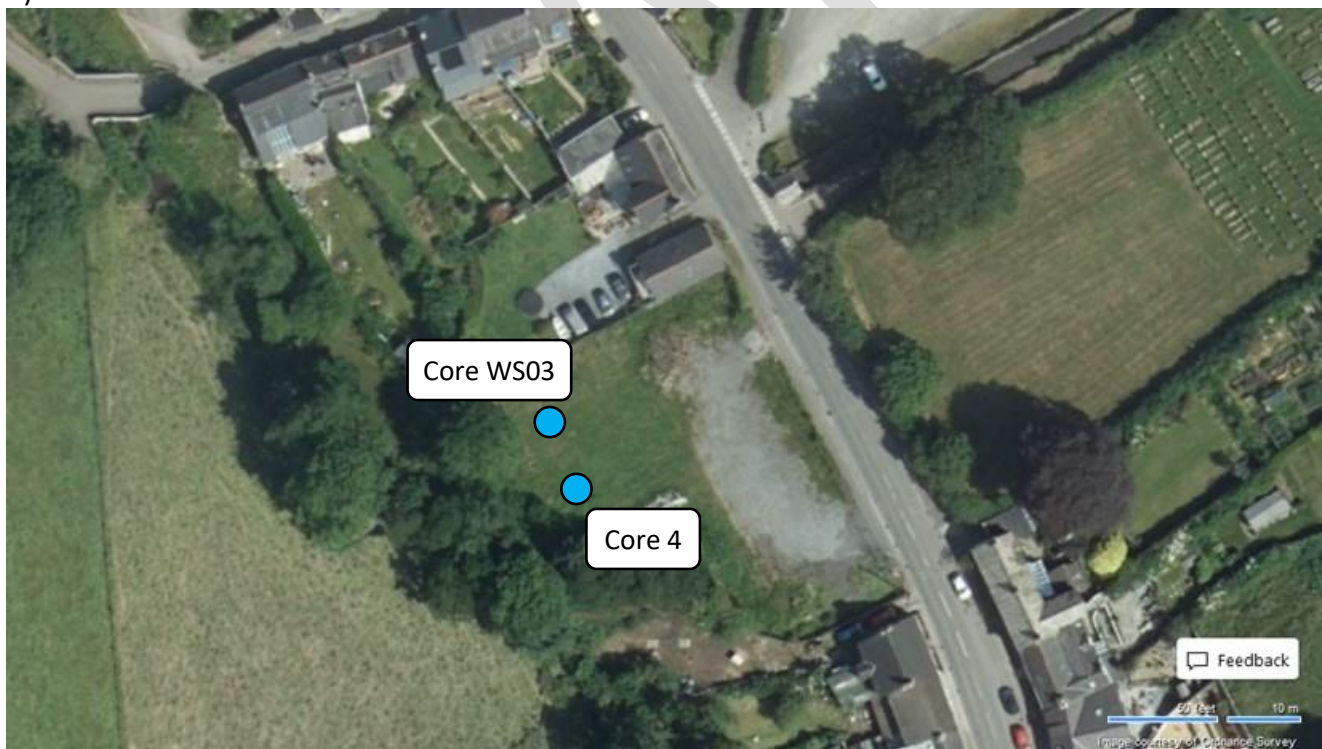
Figure 2: Location of coring sites initially drilled in November 2021 and then subsequently redrilled in July 2022: A) salt flats, and B) Clifton Street. Base image from Bing Maps.

In November 2021 a 2-day coring programme was undertaken at 4 locations (Figure 2). The purpose of this programme was to recover sediment for logging and the recovery of material for  $^{14}\text{C}$  dating (see section 2.3). Core 1, on the saltmarsh, was located with the aim of recovering an estuarine record of sedimentation, whereas core 2 was located to recover a combination of fluvial (R. Coran) and estuarine activity. Cores 3 and 4 at the Clifton Street building plot site were located sufficiently upstream to just contain a record of fluvial (R. Coran) activity.

Due to poor sediment recovery and the disturbed nature of several cores, a second drilling programme was undertaken with QuantumGeotech in July 2022 at the same locations. Three cores were recovered and logged (core locations 1-3; Figure 2) using the same protocol as outlined in section 2.1, and carefully examined for the presence or organic materials (e.g. wood, charcoal, shell fragments) that could be used for subsequent radiometric carbon-14 dating ( $^{14}\text{C}$ ).
